# Manhole Inspection Summary

Manhole # S19MM\_018MH

Insp Date: **7/3/07 1:08 PM**

**Location** Address: **2258 ELGIN AVE**

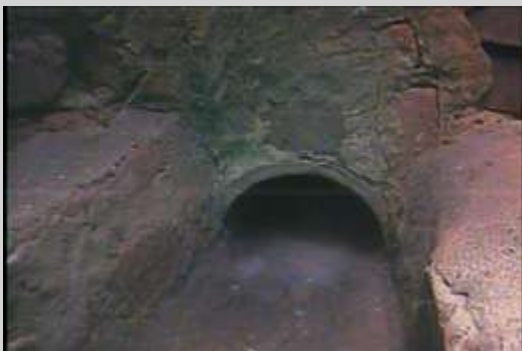
3 O'Clock Inflow

8 in. Circular Gravity Sewer  
Pipe In @ 3 O'Clock

Pipe Height: **7.2** (in.) Rod and Bar (Angled)  
Pipe Material: **Clay** ☐ Pipe Lined  
Invert Depth: **5.52** (ft.) Flow Characteristics: **Slow**  
Deposits: ☒ **None** ☐ Mud ☐ Sludge ☐ Debris ☐ Grease  
Silt Depth: (in.) Deposits Extent:  
Infiltration: **None** Pipe Seal Cond: **Sound**

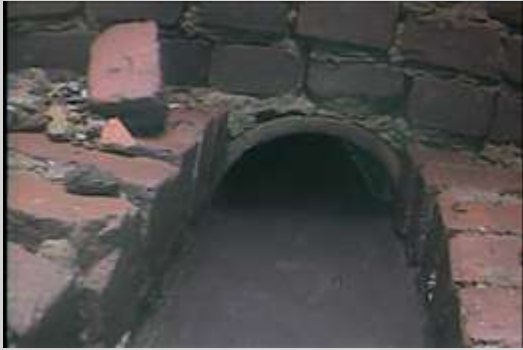
5 O'Clock Inflow

8 in. Circular Gravity Sewer

Pipe In @ 5 O'Clock

Pipe Height: **7.2** (in.) Rod and Bar (Angled)

Pipe Material: **Clay** ☐ Pipe Lined

Infiltration: **None** Pipe Seal Cond: **Sound**
